| Heritage Asset Survey | | | | | | |
| Former Stables And Outbuildings | | | LL5016 | | | |
| Cavendish Mews | | | | | | |

| DUOTOCDADUIC | Client | RUSHMOOR BOROUGH COUNCIL | Title | LOCAL LIST PHOTOGRAPHIC LOG |

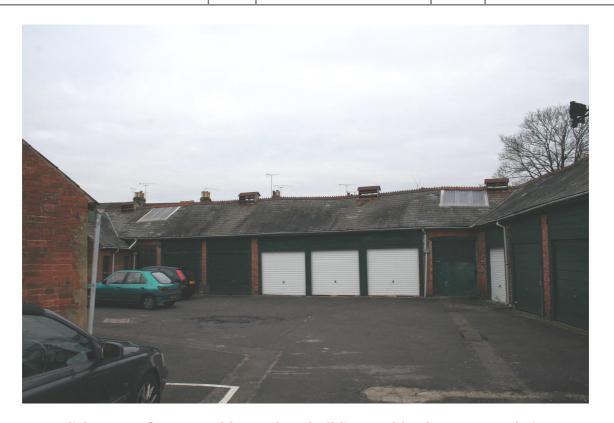
Cavendish Mews, former stables and outbuildings, Aldershot – general view

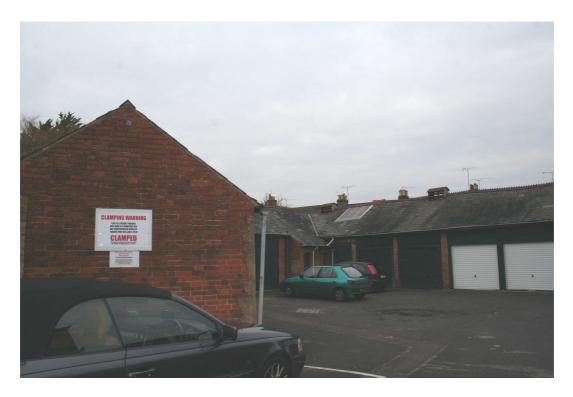
Cavendish Mews, former stables and outbuildings, Aldershot – general view

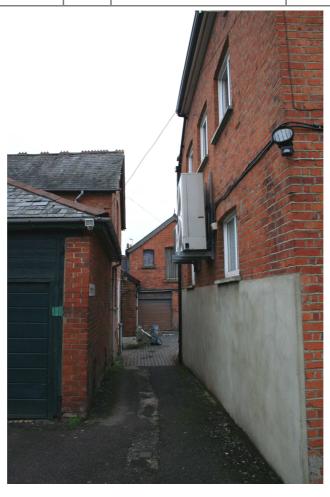
Cavendish Mews, former stables and outbuildings, Aldershot – view through to eastern range

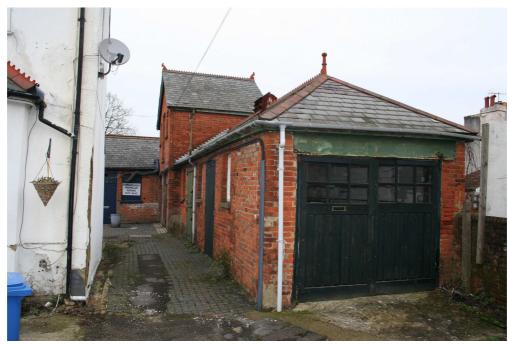
Cavendish Mews, former stables and outbuildings, Aldershot – eastern range

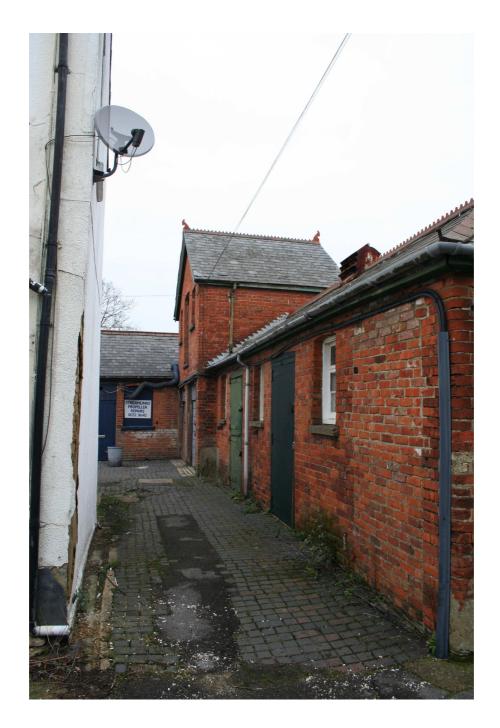
Cavendish Mews, former stables and outbuildings, Aldershot – eastern range
