| Heritage Asset Survey | | | | | |
| Boundary Wall to Cedar Court | | | LL5027 | | |
| 3 Eggars Hill | | | | | |

PHOTOGRAPHIC LOG - LL5027

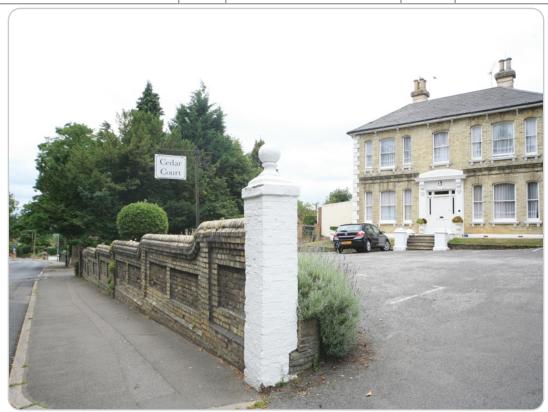
Any Further Comments: Spalling to some bricks wall appears to lean out slightly to road at lower stages

Boundary wall to Cedar Court (E elevation)Eggars Hill, Aldershot
