Heritage Asset Survey					
Building Name:		Building Reference Number:			
Empire Banqueting Hall		LL5189			
Building Address:		Listing Grade:			
High Street Aldershot GU11 1DJ		I II II			
		II* Locally Listed +			
Date Listed: 22 December 2020		Conservation Area: Yes: No: +			
Condition Survey: 1 - 5 1 Very Bad 2 Poor 3 Fair 4 Good 5 Excellent					
Feature		Issue identification			
Boundary Walls or Gates	n/a	Local Building Cracking	Y		
Outbuildings	n/a	Rising Damp	n/a		
Abutments	n/a	Roof spread	n/a		
Roof	n/a	Sag	n/a		
Chimneys	n/a	Settlement	n/a		
Flashing	n/a	Stability/ Plumb	n/a		
Weathering Detail (Valleys etc.)	n/a	Spalling	Υ		
Walls (masonry/brickwork/render)	3	Weather Penetration	n/a		
Pointing	3				
Rainwater Goods	3				
Windows	3/4				
Doors and Surroundings	3				
Lintels	n/a				
Other Features	n/a

Historical Context:

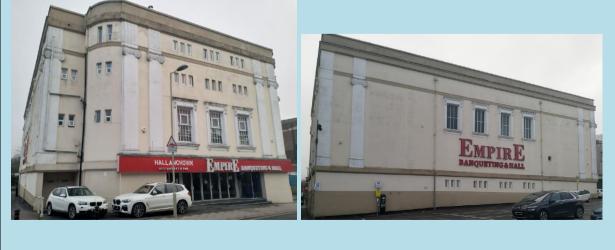
Date Taken:/ Source: HE, NSL 1909			
Any Further Comments: Building appears to be well maintained, however there are some small localised areas of spalling and cracking of render.			
Surveyor: I.M	Date: 08/12/20
