Heritage Asset Survey						
Building Name:		Building Reference Number:				
Inglis Bridge		LL5196				
Building Address:		Listing Grade:				
n/a – Structure over the Basingstoke Canal						
		II* Locally Listed +]			
Date Listed: 22 December 2020		Conservation Area: Yes: No: +				
Condition Survey: 1 - 5 1 Very Bad 2 Poor 3 Fair 4 Good 5 Excellent						
Feature		Issue identification				
Boundary Walls or Gates	n/a	Local Building Cracking	n/a			
Outbuildings	n/a	5	n/a			
Abutments	n/a		n/a			
Roof	n/a		n/a			
Chimneys	n/a		n/a			
Flashing	n/a		n/a			
Weathering Detail (Valleys etc.)	n/a	5	n/a			
Walls (masonry/brickwork/render)	n/a		Y – timbers rotting			
Pointing	n/a					
Rainwater Goods	n/a					
Windows	n/a					
Doors and Surroundings	n/a					
Lintels	n/a					
Other Features	2

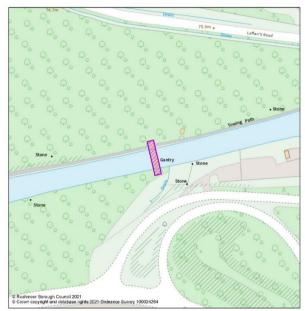
Any Further Comments: A survey of the structures condition was undertaken. The timbers of the bridge are in poor condition with extensive rot evident. The steel components of the structure appeared to be in good condition.
