## Heritage Asset Survey

Heritage Asset Survey											
Building Name:	Building Reference Number:										
No.15 Albert Road	LL5001										
Building Address:	Listing Grade:										
15 Albert Road Aldershot Hampshire GU11 1SZ	<table style="width: 100%; border: none;"> <tr> <td style="width: 25%;">I</td> <td style="width: 25%; text-align: center;"><input type="checkbox"/></td> <td style="width: 25%;">II</td> <td style="width: 25%; text-align: center;"><input type="checkbox"/></td> </tr> <tr> <td>II*</td> <td style="text-align: center;"><input type="checkbox"/></td> <td>Locally Listed</td> <td style="text-align: center;"><input style="width: 20px; height: 20px;" type="checkbox" value="+"/></td> </tr> </table>	I	<input type="checkbox"/>	II	<input type="checkbox"/>	II*	<input type="checkbox"/>	Locally Listed	<input style="width: 20px; height: 20px;" type="checkbox" value="+"/>		
I	<input type="checkbox"/>	II	<input type="checkbox"/>

<b>PHOTOGRAPHIC LOG - LL5001</b>	<b>Client</b>	RUSHMOOR BOROUGH COUNCIL	<b>Title</b>	LOCAL LIST PHOTOGRAPHIC LOG
	<b>Date</b>	04/08/10	<b>Signed</b>	<i>SBHale</i>

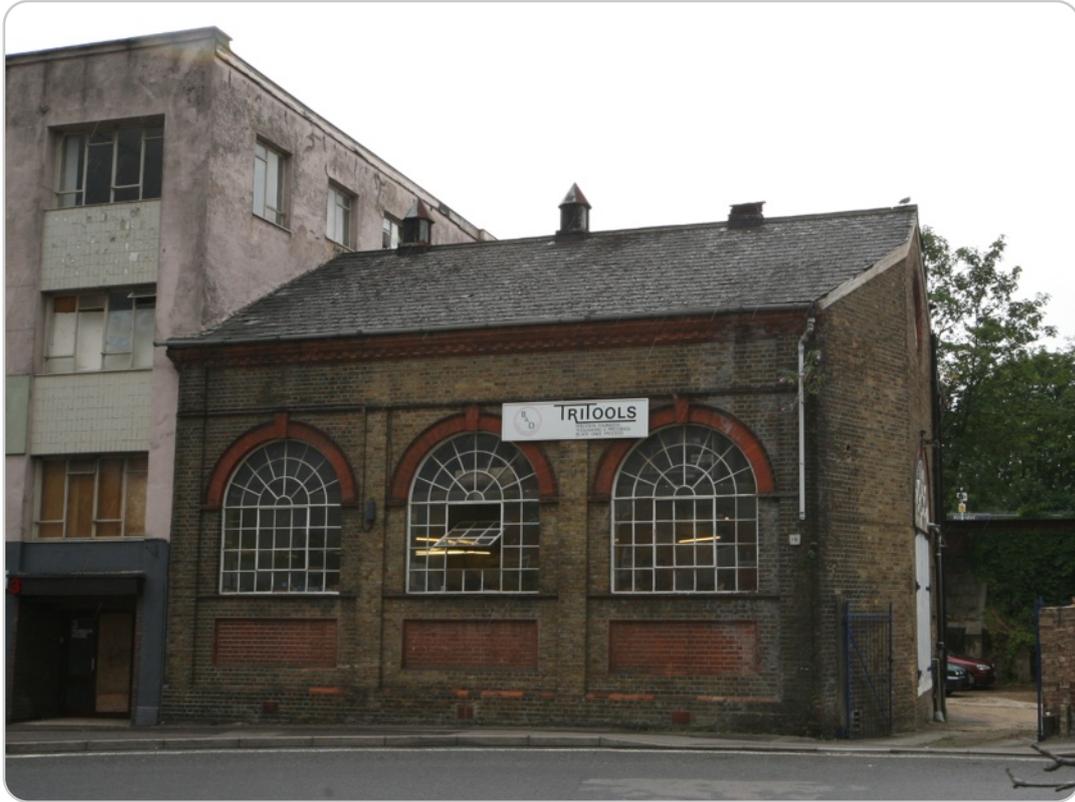
**No. 15 Albert Road (NW elevation)**

Company	<input checked="" type="checkbox"/>	Crown	<input type="checkbox"/>
Photographs			
Date Taken: 04/08/10			
<p>Any Further Comments: Occupied by engineering firm Tri-tools</p> <p>High-level vegetation growth, missing downpipe section, rotten timber bargeboards, poor flashing covering to adjacent building</p>			
Surveyor:	SH	Date:	04/08/10
