Heritage Asset Survey					
Building Name:			Building Reference Nur	mber:	
Imperial House			LL5008		
Building Address:			Listing Grade:		
2 Grosvenor Road					ı
Aldershot			1		
Hampshire					
GU11 1DP			II* Lecolly	, Liete d	
The Control of the Mark	БП		II* Locally	/ Listed +	
Listing Criteria Met	B, H				
(see Box B of the					
SPD)	00th B4   0040		O	Maria Na

## PHOTOGRAPHIC LOG - LL5008

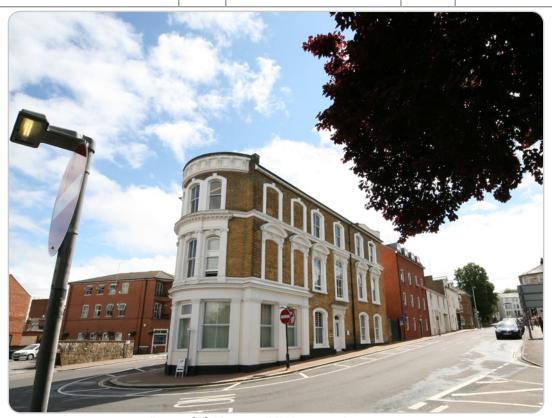
Imperial House (NW corner)

Parapet roof prevented inspection of roof covering. Low level staining perhaps suggestive of damp
