Heritage Asset Survey								
Building Name:			Building Reference Number:					
			LL5014					
Building Address:			Listing Grade:					
29 - 31 Cargate Avenue			. —	ı				
Aldershot				II				
Hampshire								
Listing Oritoria Mat			*		cally Listed			
Listing Criteria Met (see Box B of the	B, G, H, K		"	LU		+		
SPD)								
Date Locally Listed:	26th March 2012		Conconv	tion Aroa:	Yes: +	No:		
Pair of semi-d							+ h	
				_				
natural slate	—							
attic. Recesse	d 2 central	bay	's flan	ked by	gabled b	ays w	ith	
double height	canted bay w	vind	lows. R	ed bri	ck in str	etcher	r	
bond with red	brick and te	erra	cotta	detail	ing and h	ipped		
slate roof wit					2		2

Historical Context:

Large Villa pair in the high-status Cargate development of the 1890s

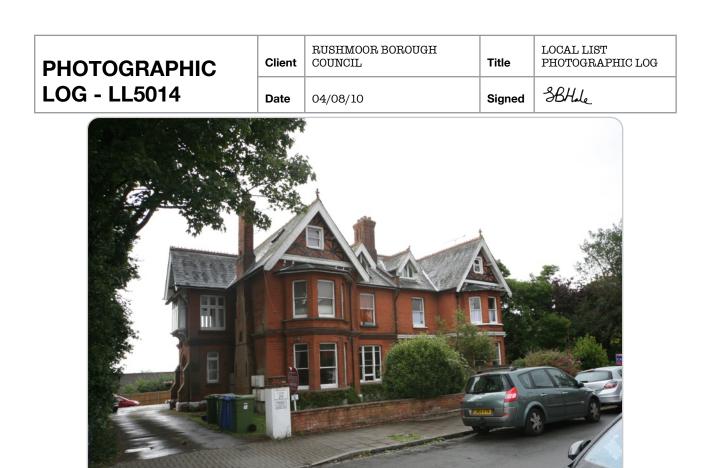
No.29 & 31 (NW corner) Cargate Avenue, Aldershot

1					
Private	+	Local Authority				
Religious / Charity		Stat Undertakers				
Religious / Chanty		Stat Ondertakers				
Company		Crown				
Photographs						
Date Taken: 04/08/10						
Dale Takell. 04/00/10						
Any Further Comments:						
Some evidence of timber degradation to high-level windows and bargeboards						
Surveyor: SH		ate: 04/08/10
