Heritage Asset Survey

| PHOTOGRAPHIC LOG - LL5026 | Client | RUSHMOOR BOROUGH COUNCIL | Title | LOCAL LIST PHOTOGRAPHIC LOG |

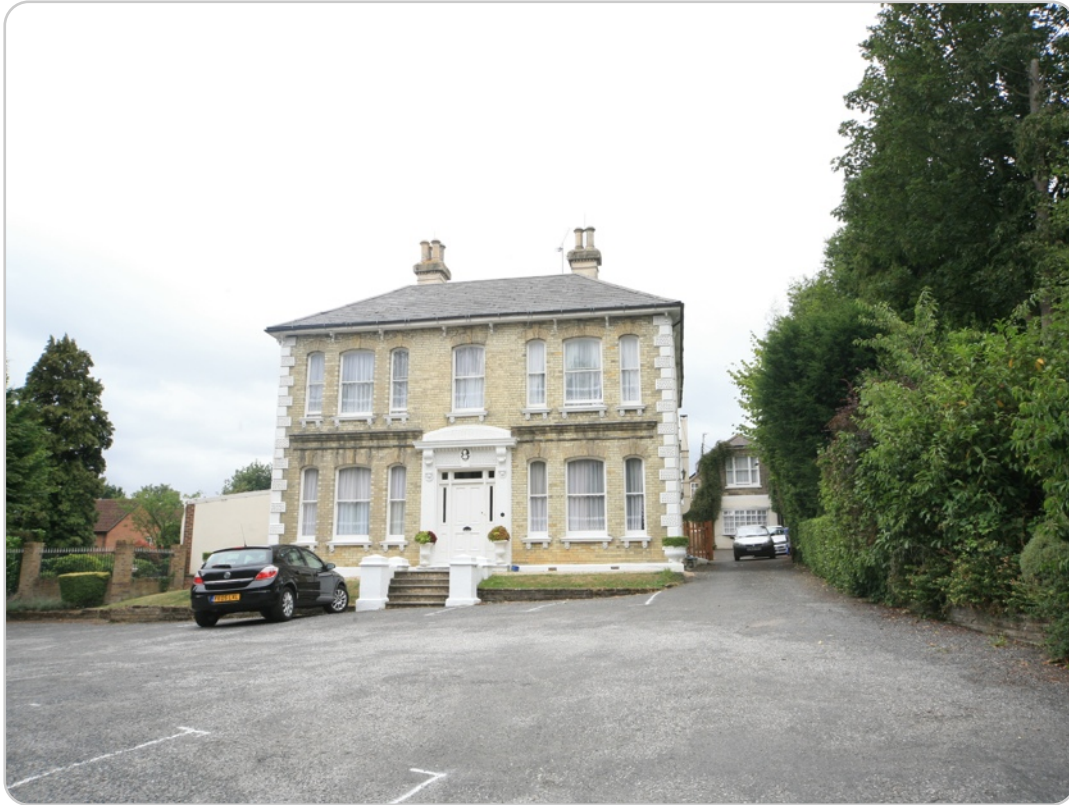
*Cedar Court (E elevation)
3 Eggars Hill, Aldershot*

| Any Further Comments: Historic movement with cracking to central keystone at first floor. | | | |
