## Heritage Asset Survey

Building Name:		Building Reference Number:	
Gates To Former Royal Pavilion		LL5029	
Building Address:		Listing Grade:	
Farnborough Road Aldershot Hampshire		I <input type="checkbox"/>	II <input type="checkbox"/>
Listing Criteria Met (see Box B of the SPD)	B, H, I	II* <input type="checkbox"/>	Locally Listed <input type="checkbox"/> +
Date Locally Listed:	26 <sup>th</sup> March 2012	Conservation Area:	Yes: <input type="checkbox"/> No: +
<p>Gates, gate piers and screens. c1855 Cast iron. Double gates with cross bracing and Y finials and scrolls. Flanking pedestrian gates and railings in matching design but without cross bracing. Gate piers have moulded cappings. Screens have low brick plinth with stone capping.</p> <p>The gates, gate piers and screen railings form a group with the Grade II listed Guardhouse to the former Royal Pavilion.</p> <p>Condition Survey: 1 - 5</p> <p style="text-align: center;"> <input type="radio"/> 1 Very Bad                <input type="radio"/> 2 Poor                <input type="radio"/> 3 Fair                <input type="radio"/> 4 Good                <input type="radio"/> 5 Excellent         </p>

<b>PHOTOGRAPHIC LOG - LL5029</b>

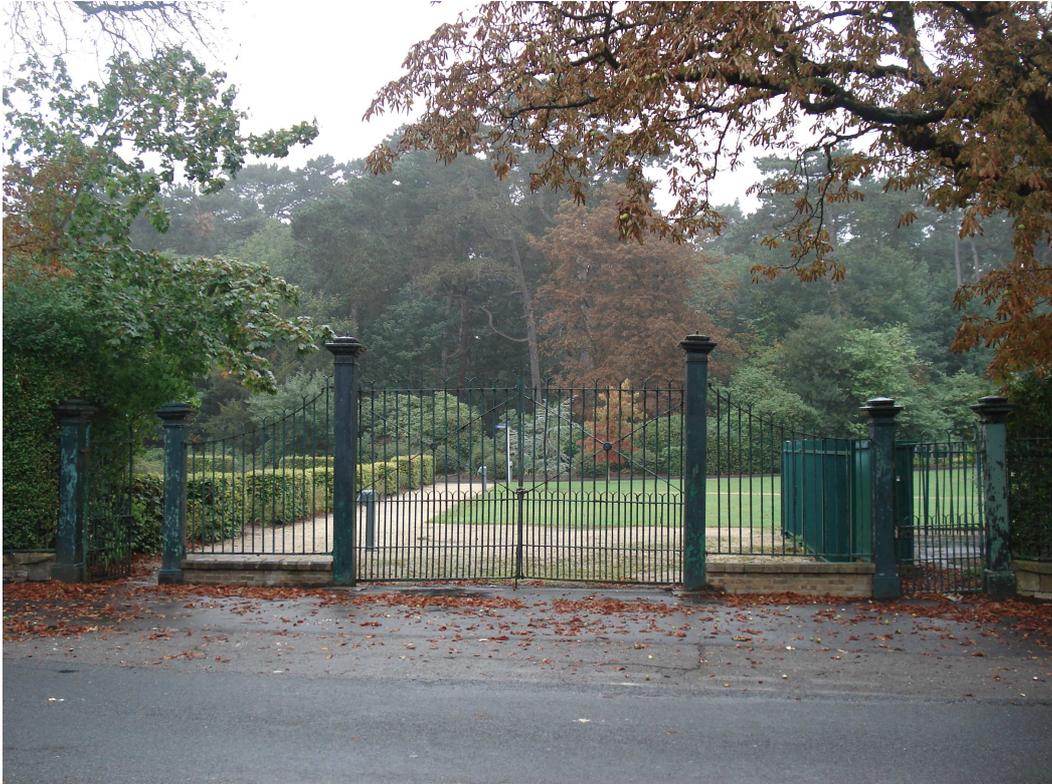
Gates to former Royal Pavilion, Farnborough Road (North-west side), Aldershot

Excessive paint peeling. Localised corrosion and some failure of stonework where railings are caulked into the stone. Cracked stone plinth with missing pointing.
