Building Name:   Crane, Ash Lock   LL5045	Heritage Asset Survey							
Crane, Ash Lock Building Address: Government Road Aldershot Hampshire  Listing Criteria Met (see Box B of the SPD)  Date Locally Listed: 26th March 2012  Hand crane on Basingstoke Canal. c1850s. Cast and wrought iron. (similar to those produced by the John Stevenson Canal Foundry, Preston). Rotating hand crane comprising a series of gears secured to a vertical post set in a base. Cast-iron frame with jib and stays. Chain with open hook.  A good survival of a once common feature to the wharfs and locks of the canals of England and Wales.  The crane and adjacent lock and Ash Lock Cottage (Grade II listed) form a group  Condition Survey: 1-5  1 Very Bad 2 Poor 3 Fair 4 Good 5 Excellent  Roof  n/a Walls  Weather Penetration  n/a Stability  n/a  Spread  n/a Plumb  n/a  Covering  n/a Pointing  n/a Roofspread  n/a Roofspread  n/a Roofspread  n/a Roofspread  n/a EV. Rising Damp  n/a  Rain Water Goods  n/a Lintels  n/a Lintels	Building Name:			Building Reference Number:

Client	RUSHMOOR BOROUGH COUNCIL	Title	LOCAL LIST PHOTOGRAPHIC LOG
PHOTOGRAPHIC				ARALA
LOG - LL5045	Date	23/09/2010	Signed	MLATO:

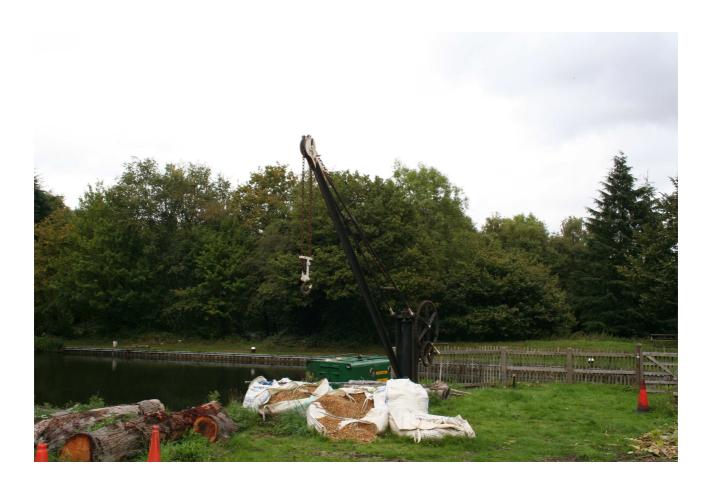
In a reasonable condition but vulnerable to neglect, it is not clear whether it is still in use?

Crane at Ash Lock, Government Road, Aldershot
