Heritage Asset Survey

Heritage Asset Survey									
Building Name:	Building Reference Number:								
	LL5080								
Building Address:	Listing Grade:								
3 - 11 Wellington Street And 49 - 51 Union Street Aldershot Hampshire	<table style="width: 100%; border: none;"> <tr> <td style="width: 25%;">I</td> <td style="width: 25%; text-align: center;"><input type="checkbox"/></td> <td style="width: 25%;">II</td> <td style="width: 25%; text-align: center;"><input type="checkbox"/></td> </tr> <tr> <td>II*</td> <td style="text-align: center;"><input type="checkbox"/></td> <td>Locally Listed</td> <td style="text-align: center;"><input style="width: 20px; height: 20px; vertical-align: middle;" type="checkbox" value="+"/></td> </tr> </table>	I	<input type="checkbox"/>	II	<input type="checkbox"/>	II*	<input type="checkbox"/>	Locally Listed	<input style="width: 20px; height: 20px; vertical-align: middle;" type="checkbox" value="+"/>

PHOTOGRAPHIC LOG - LL5080	Client	RUSHMOOR BOROUGH COUNCIL	Title	LOCAL LIST PHOTOGRAPHIC LOG
	Date	04/08/10	Signed	<i>SBHale</i>

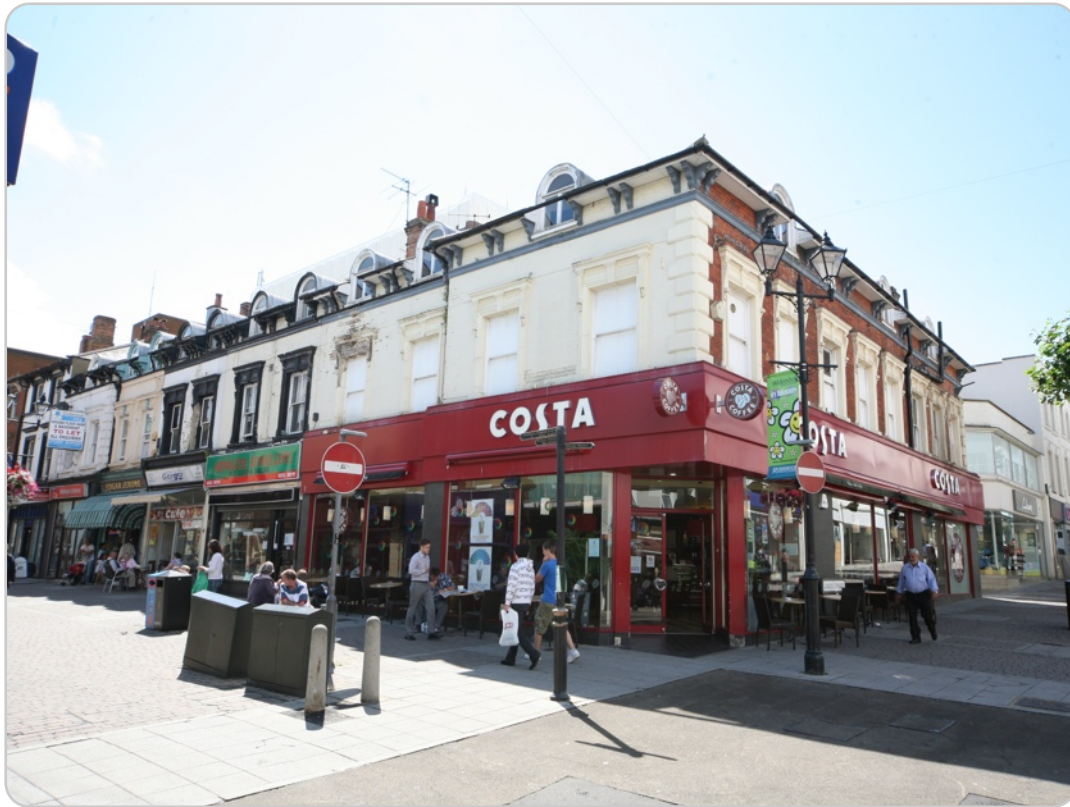
Union Street / Wellington Street, Aldershot

Vegetation growth on downpipe to corner shop. Significant water staining from poorly maintained rainwater goods on Wellington Street frontage with staining and damage to stucco window surrounds. Guttering appears to have recently been replaced.

Nos. 49-51 Union Street, Nos.3-11 Wellington Street (N corner)
