## Heritage Asset Survey

| Post Office | LL5102 | | | | | | | | |
| 108 Alexandra Road<br>Farnborough<br>Hampshire<br>GU14 6DG | <table style="width: 100%; border: none;"> <tr> <td style="width: 25%;">I</td> <td style="width: 25%; text-align: center;"><input type="checkbox"/></td> <td style="width: 25%;">II</td> <td style="width: 25%; text-align: center;"><input type="checkbox"/></td> </tr> <tr> <td>II*</td> <td style="text-align: center;"><input type="checkbox"/></td> <td>Locally Listed</td> <td style="text-align: center;"><input style="width: 20px; height: 20px; vertical-align: middle;" type="checkbox" value="+"/></td> </tr> </table> | I | <input type="checkbox"/> | II | <input type="checkbox"/> | II* | <input type="checkbox"/> | Locally Listed | <input style="width: 20px; height: 20px; vertical-align: middle;" type="checkbox" value="+"/> |

| <b>PHOTOGRAPHIC<br/>LOG - LL5102</b> | <b>Client</b> | RUSHMOOR BOROUGH<br>COUNCIL | <b>Title</b> | LOCAL LIST<br>PHOTOGRAPHIC LOG |

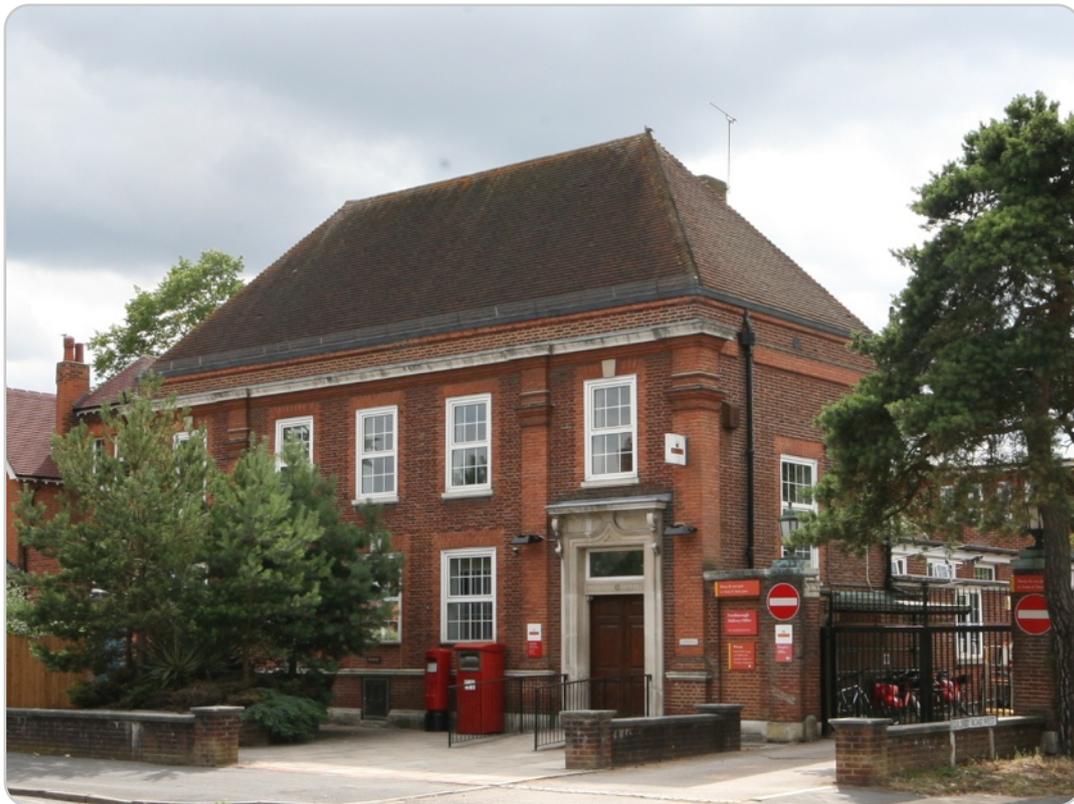
**Post Office (E elevation)**  
Alexandra Road, Farnborough

| Any Further Comments: One or two missing roof tiles. | | | |
