Heritage Asset Survey							
Building Name:			Building Reference Number:				
			LL5105				
Building Address:			Listing Grade:				
11 - 15 Camp Road							
Farnborough			1   11				
Hampshire							
Listing Criteria Met (see Box B of the SPD)	В		II* L	ocally L	₋isted	+	
Date Locally Listed:	26th March 2012		Conservation Area	a: \	Yes:	No: +	
Shops with accommodation above. c1910. Red and brown brick with faience columns between metal framed shopfronts and clay tile roof. 2-storey. Façade; ground floor green faience tiled pilasters with end consoles. Left hand; car sales garage with transom and mullion fanlight and open frontage, central shop late 20 <sup>th</sup> century shopfront but retaining transom and mullion fanlight, Right hand shop with early-mid 20 <sup>th</sup> century shopfront retaining fanlight above. Plain fascias. First floor central canted oriel with vertical sliding sashes with open pediment above with oculus window in tympanum which has a red brick surround. Red brick quoins. Flanking windows, top sash with glazing bars in red brick surrounds with flat rubbed brick arches and raised keystones. Deep eaves with modillions. Plain clay tile roof.

## PHOTOGRAPHIC LOG -

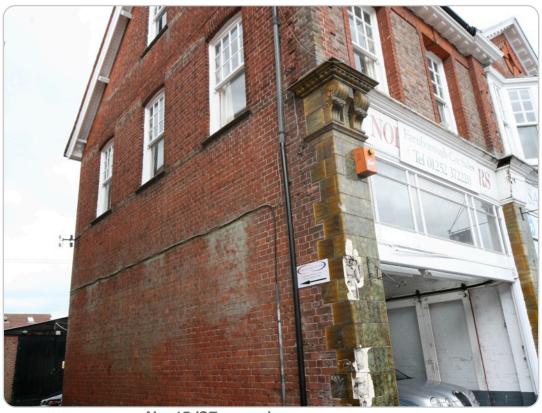
No. 15 (SE corner)
Camp Road, Farnborough

Any Further Comments: Faience on S pilaster damaged by collision of vehicles passing to the side.
