Heritage Asset Survey

Building Name:		Building Reference Number:			
Germany Block		LL5167			
Building Address:		Listing Grade:			
Thornhill Barracks Gallwey Road Aldershot Hampshire GU11 2DF		I	<input type="checkbox"/>	II	<input type="checkbox"/>
		II*	<input type="checkbox"/>	Locally Listed	<input style="text-align: center; width: 20px; height: 20px; border: 1px solid black;" type="checkbox" value="+"/>
Listing Criteria Met (see Box B of the SPD)	H, I, J				
Date Locally Listed:	26 th March 2012	Conservation Area:	Yes:	No: +

PHOTOGRAPHIC LOG - LL5167	Client	RUSHMOOR BOROUGH COUNCIL	Title	LOCAL LIST PHOTOGRAPHIC LOG
	Date	04/08/10	Signed

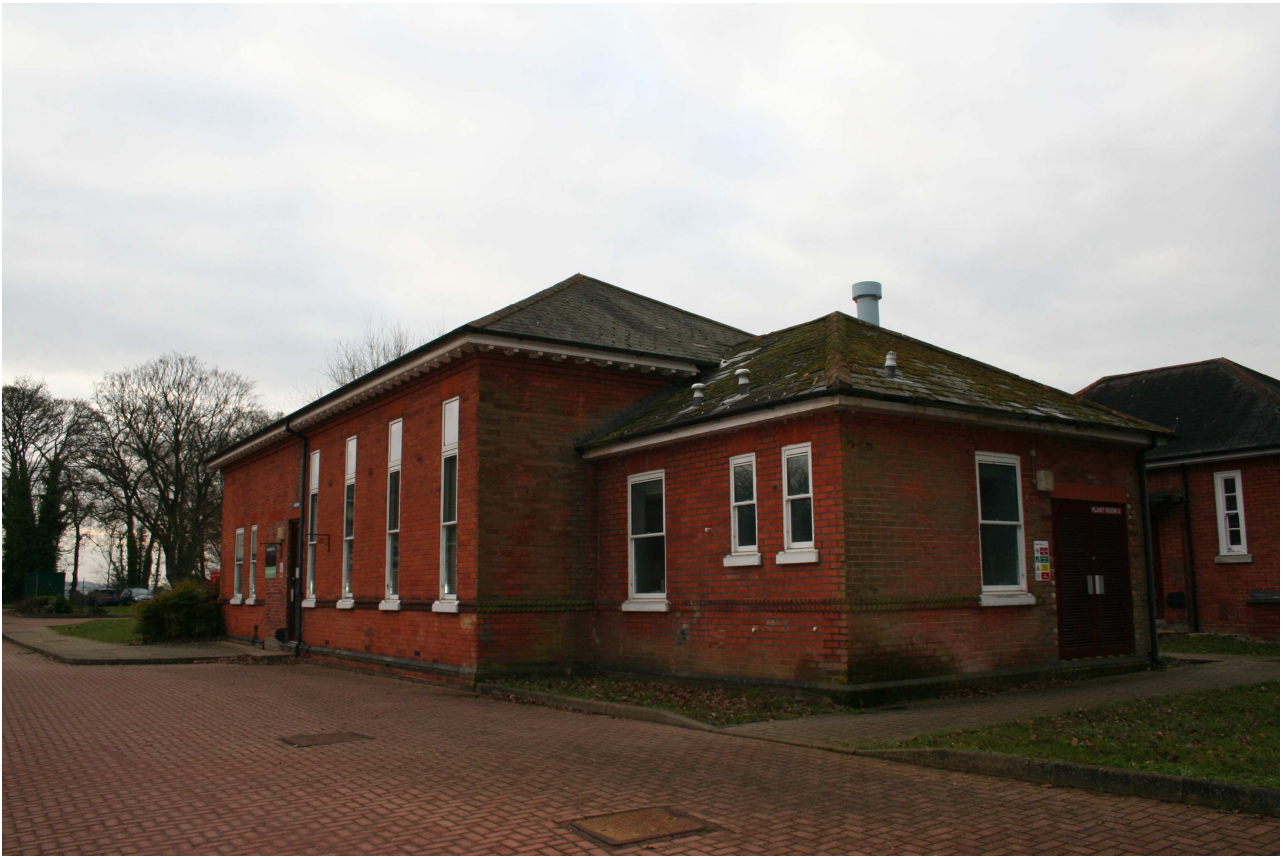
Roof appears in places to be in a poor condition, there is evidence of the failure of rainwater goods (staining to the walls) and evidence of rising damp (staining to brickwork)

Germany Block, Thornhill Barracks, Gallwey Road, Aldershot – north and east elevations
