Heritage Asset Survey

Building Name:		Building Reference Number:		
Outbuildings To North Of Fitzwygram House		LL5044		
Building Address:		Listing Grade:		
Gallwey Road Aldershot Hampshire		I <input type="checkbox"/>	II <input type="checkbox"/>	
Listing Criteria Met (see Box B of the SPD)	B, H, I, K	II* <input type="checkbox"/>	Locally Listed	<input type="checkbox"/> +
Date Locally Listed:	26 th March 2012	Conservation Area:	Yes: +	No:

Follow-on page for LL5044: Vaccine Institute, stables, Forage/shoeing shed and outbuildings to north and north-west of Fitzwygram House

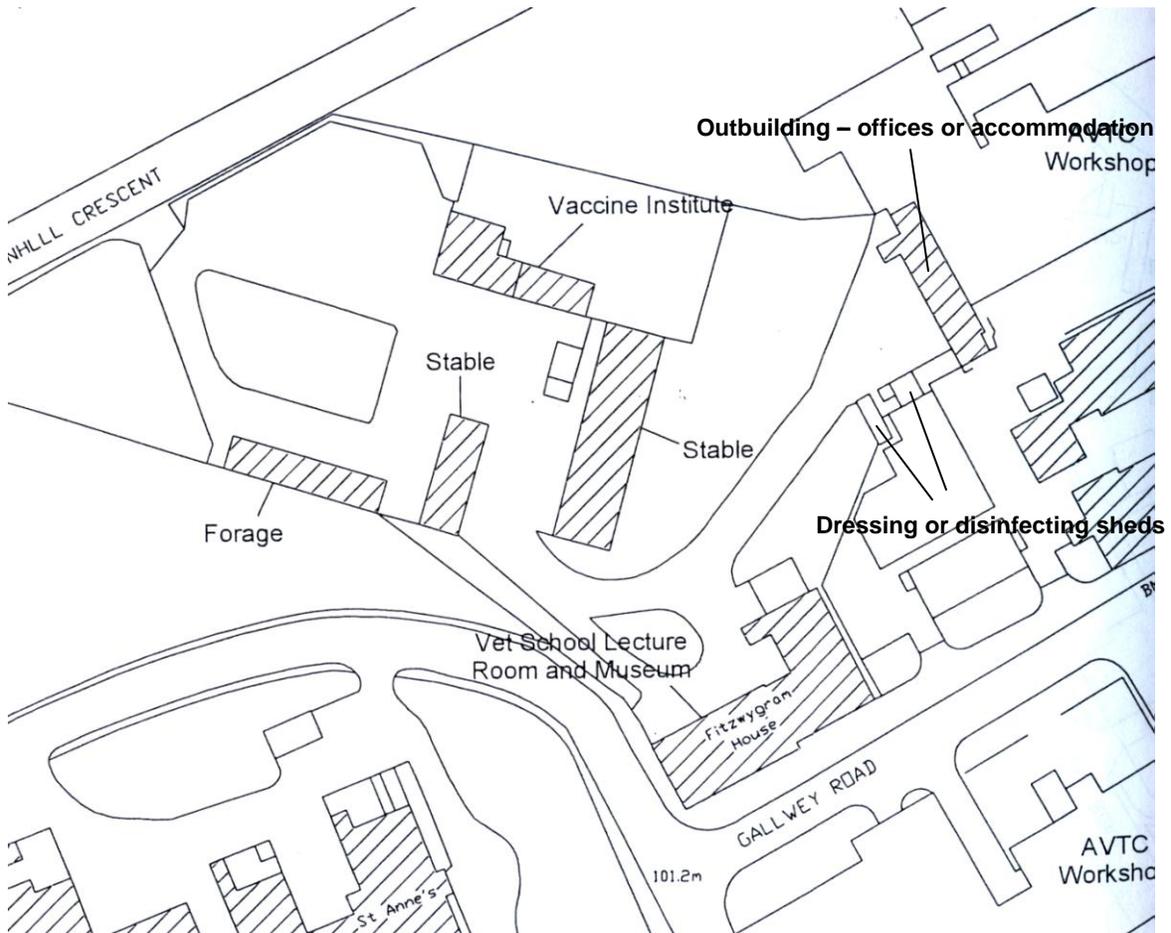
Location plan for buildings (named) which make up this group:

Vaccine Institute, stables, Forage/shoeing shed set in a loose courtyard plan to the north and north west of Fitzwygram House (please see attached location plan).

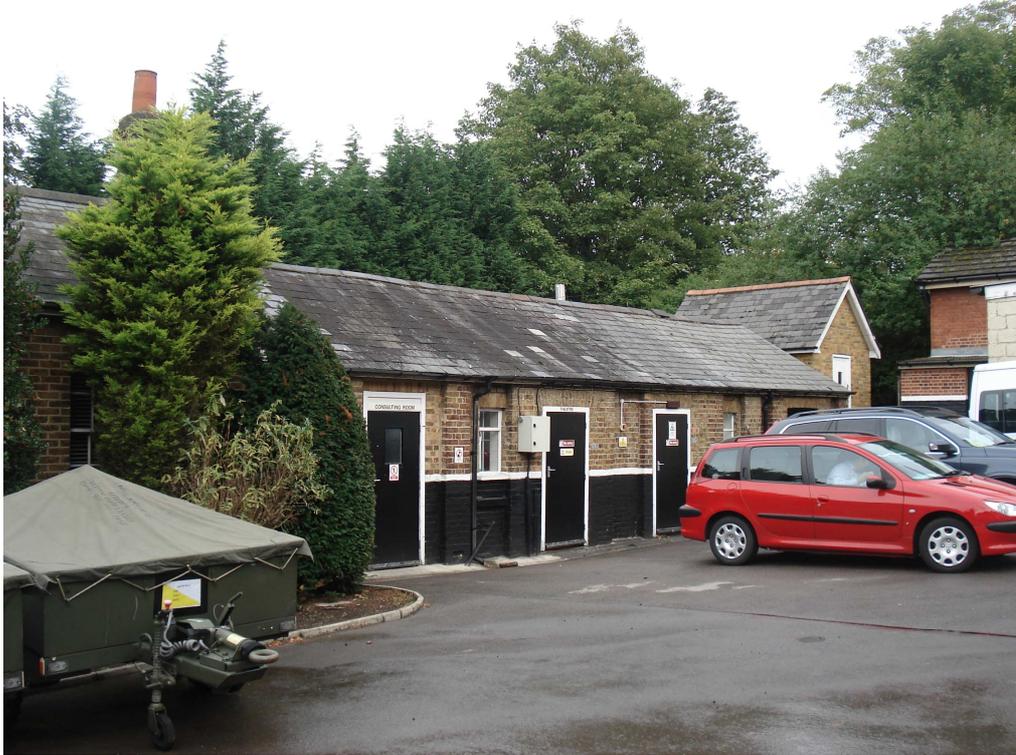
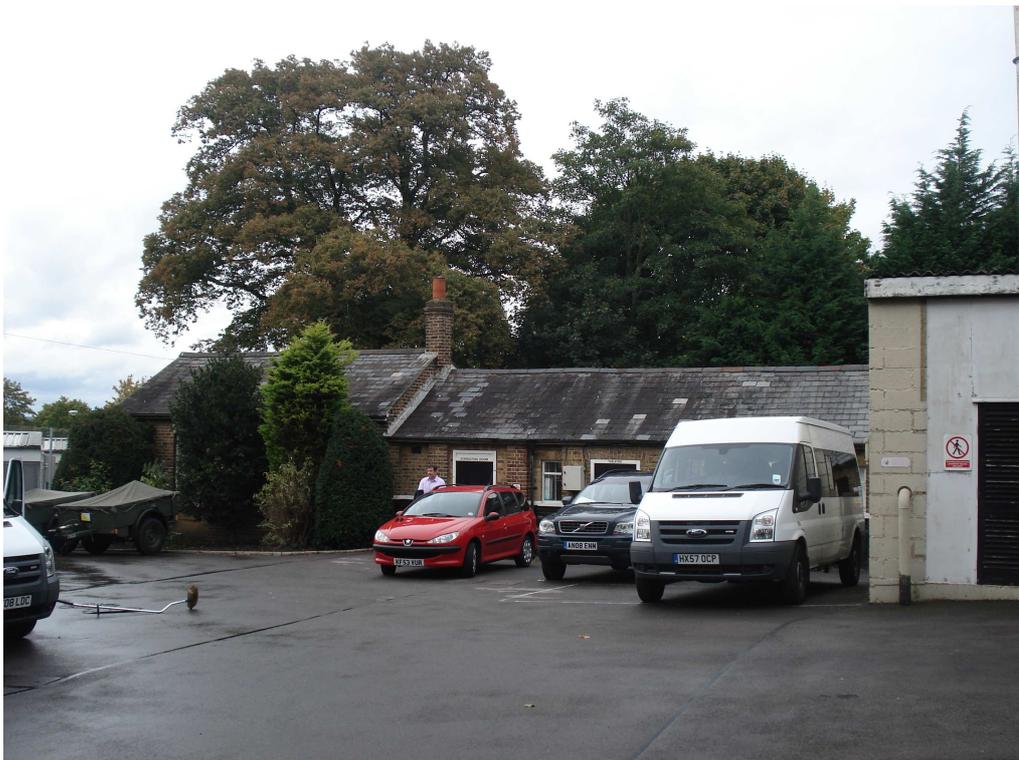
Vaccine Institute: long narrow range running east-west to the northern edge of the site. Rectangular plan of two builds. To the east four room; originally a lab, operating room, calves house and boiler house, c1880. Extension to west 1898 - offices or accommodation. Buff brick in Flemish bond to east section and in stretcher bond to west section. Pitch natural slate roof with grey ridge tiles. Single slender brick chimney to ridge at junction and change of roof plane between the two builds. Boarded doors and modern casement windows (later insertions) to east and vertical sliding timber framed sashes (six-over-six) to west.

Vaccine Institute, part of a group of outbuildings to north and north-west of Fitzwygram House, Gallwey Road, Aldershot – south elevation

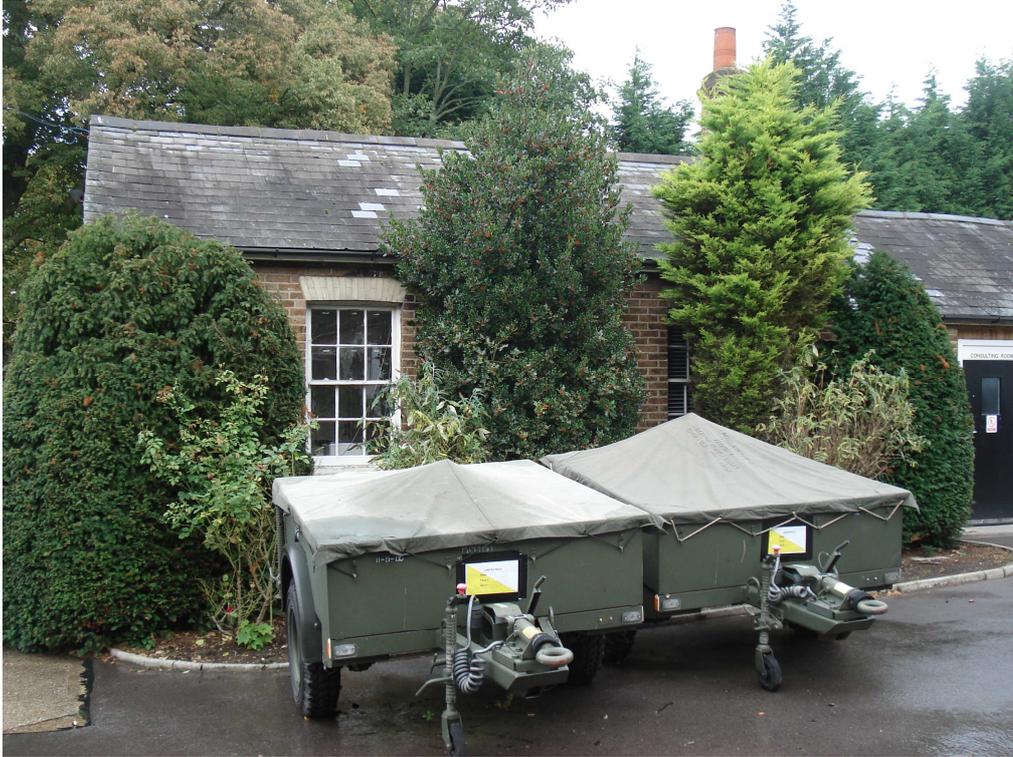
Vaccine Institute, part of a group of outbuildings to north and north-west of Fitzwygram House, Gallwey Road, Aldershot – south elevation (part)

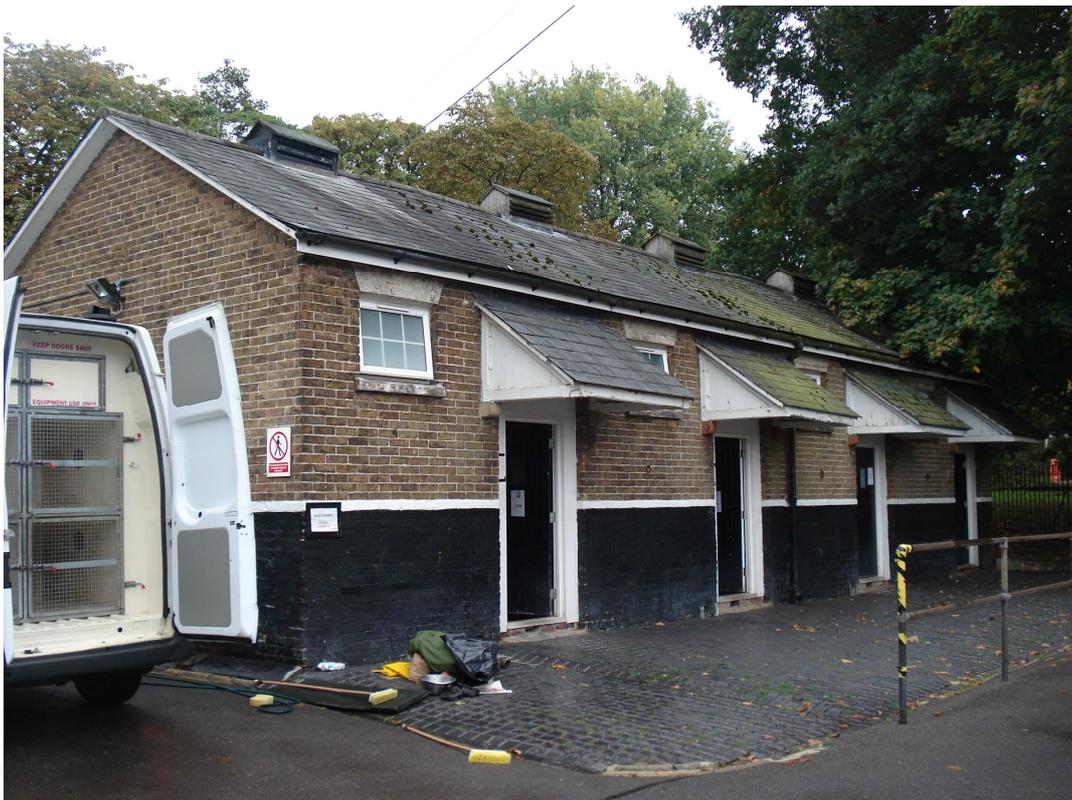
Small Stable: Smaller of two stable blocks running north-south. c1895. Narrow rectangular plan. Single storey. Buff brick in stretcher bond with pitched natural slate roof with three ridge louvered ridge vents. Four timber boarded doors with corresponding high level windows to each stall. Upvc replacements to original bottom hung casements with glazing bars (as seen to large stable). Apron of stone square section pavements to west side of block.

Small stable, part of a group of outbuildings to north and north-west of Fitzwygram House, Gallwey Road, Aldershot – east elevation

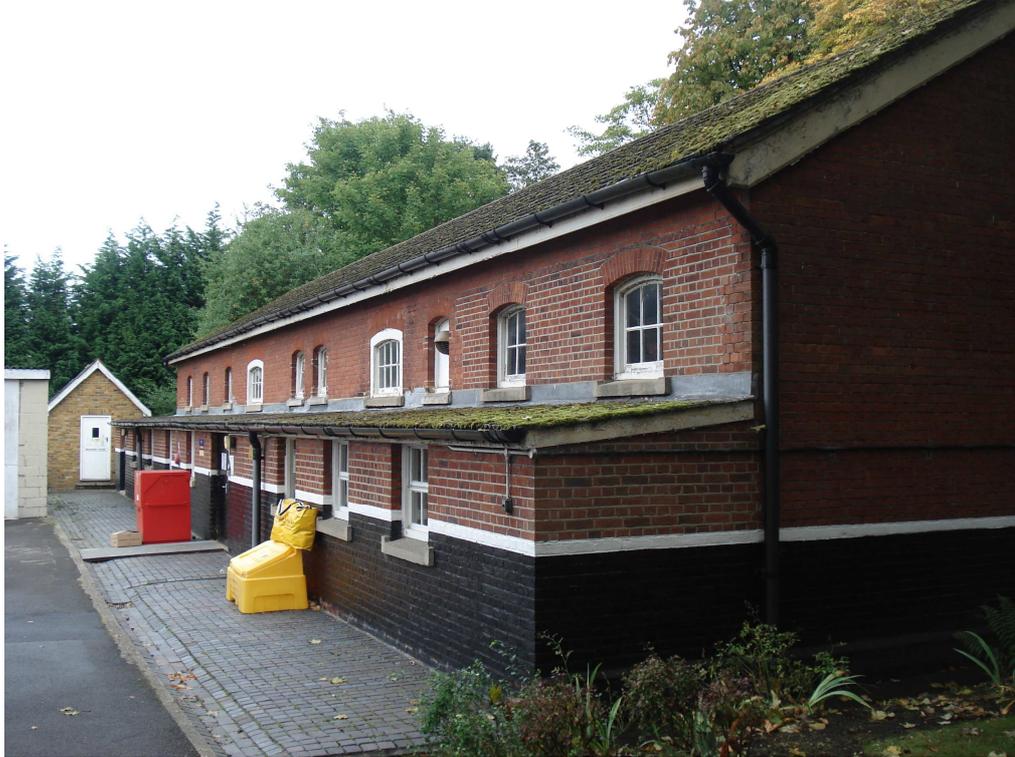
Large Stable: (closest to Fitzwygram House and forming the eastern edge of the courtyard group. Larger of two stable blocks running north-south. c1880. Single storey. Red brick in English bond, artificial slate roof. Extension to west side appears to be the infilling of a veranda. The addition has eroded the original opening and fenestration configuration. Ten high level bottom hung timber casements have cambered brick arches and are probably original to the building. Modern windows to the extension. There is an apron of stone square section pavements to west side of the block.

Large stable, part of a group of outbuildings to north and north-west of Fitzwygram House, Gallwey Road, Aldershot – west elevation

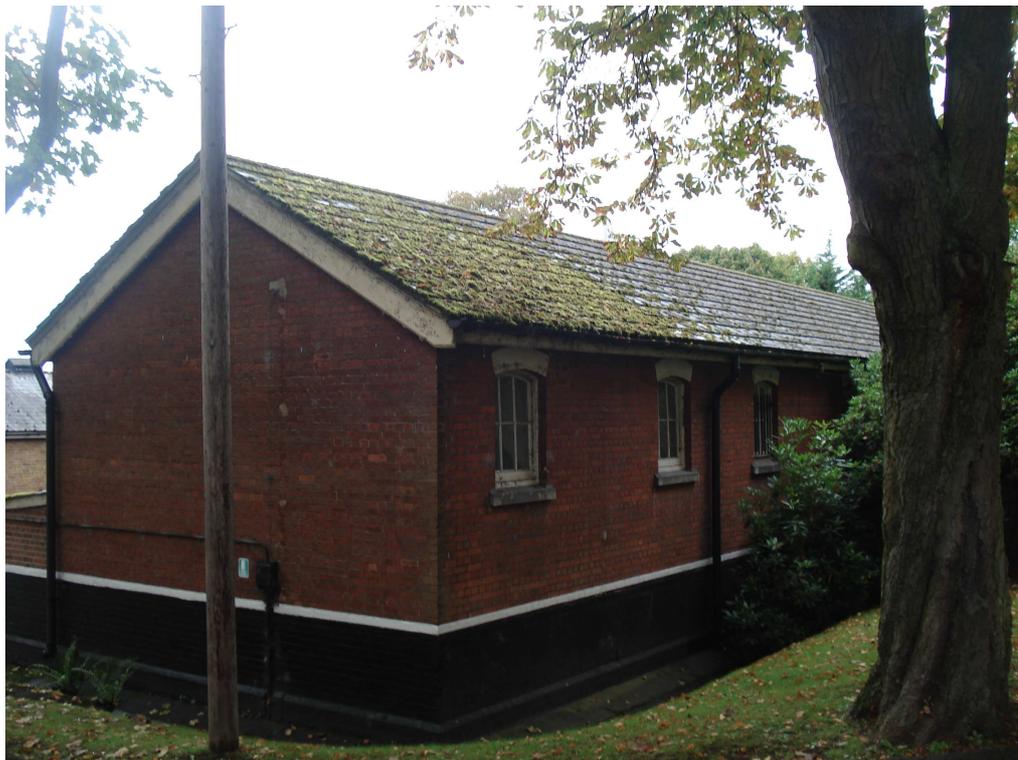
Large stable, part of a group of outbuildings to north and north-west of Fitzwygram House, Gallwey Road, Aldershot – south and part east elevation

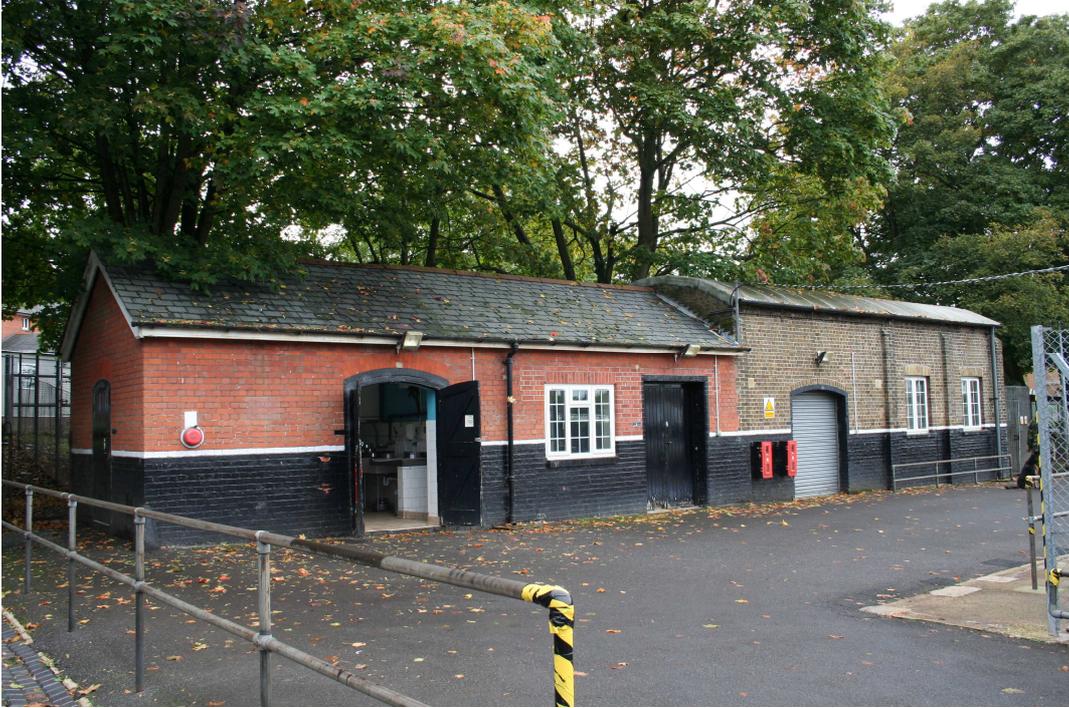
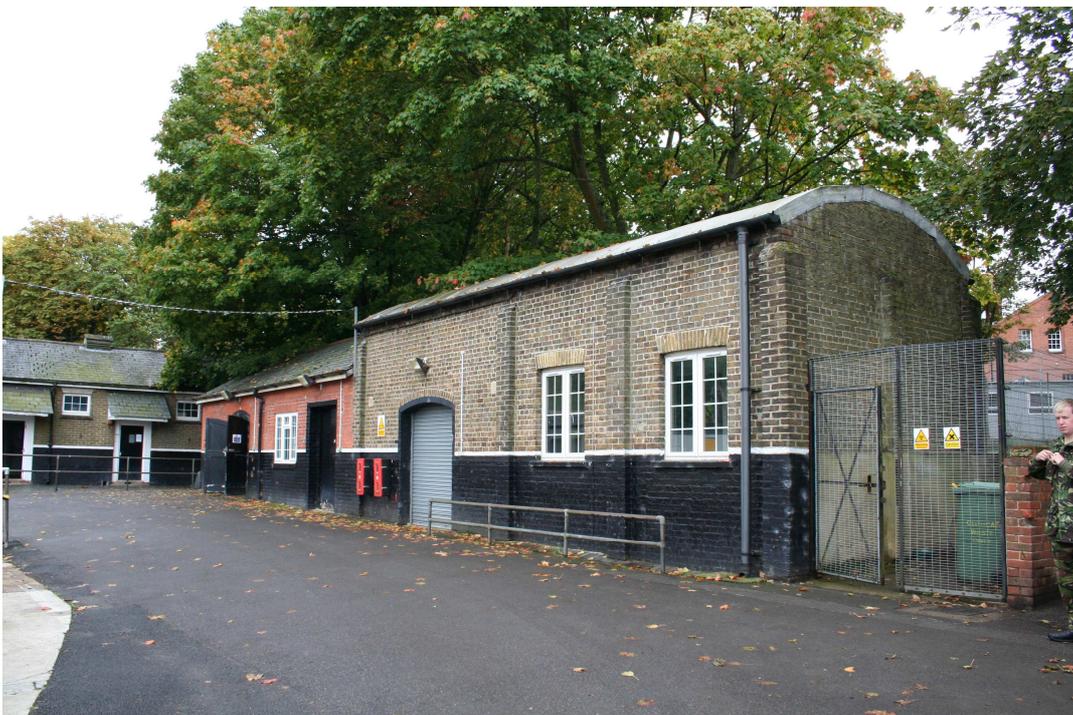
Forage/shoeing shed: Probably previously a feed store and possible shoeing shed. Narrow range running east-west along the southern edge of the courtyard group. c1895 and later. In two builds; to the east probably the earlier building in buff brick (English bond) matching the earlier buildings within this group. This section is single storey but with a high barrel roof of profile metal, probably replacing an earlier pitch natural slate roof. The western section c1900 or slightly later is red brick in English bond with a pitch natural slate roof. A high painted plinth unifies these buildings. Carriage doors to a wide opening survive to the red brick range but have been replaced with a metal roller shutter to the buff brick range. All windows are replacement Upvc casements.

Former Forage and Shoeing shed, part of a group of outbuildings to north and north-west of Fitzwygram House, Gallwey Road, Aldershot – north elevation

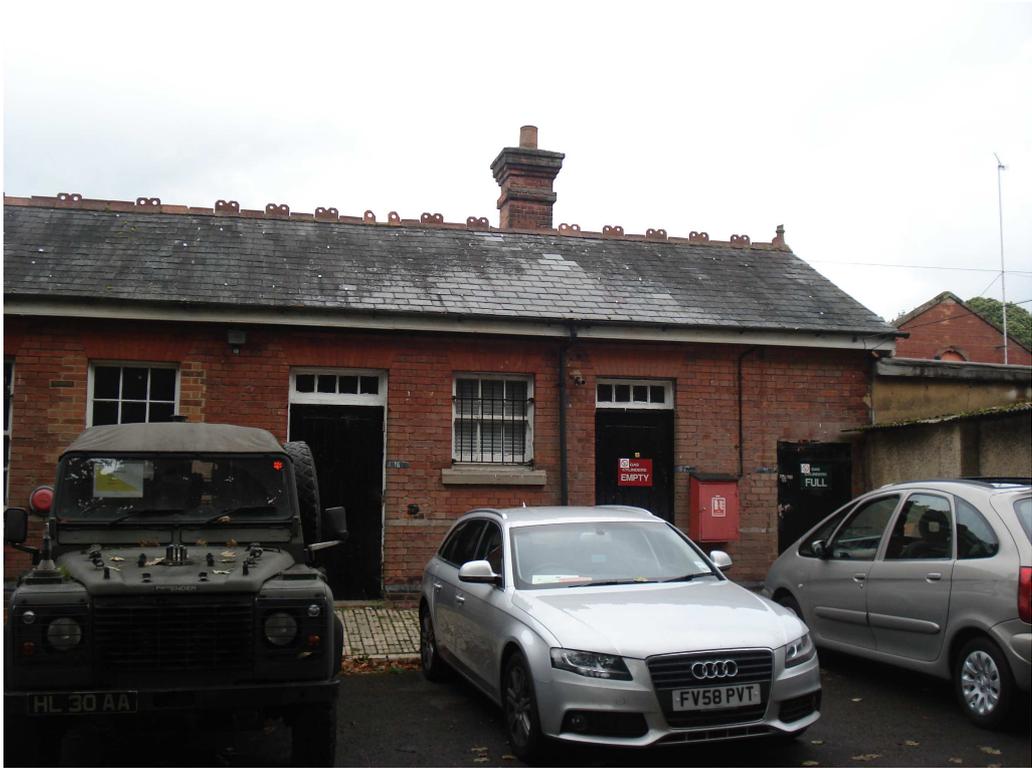
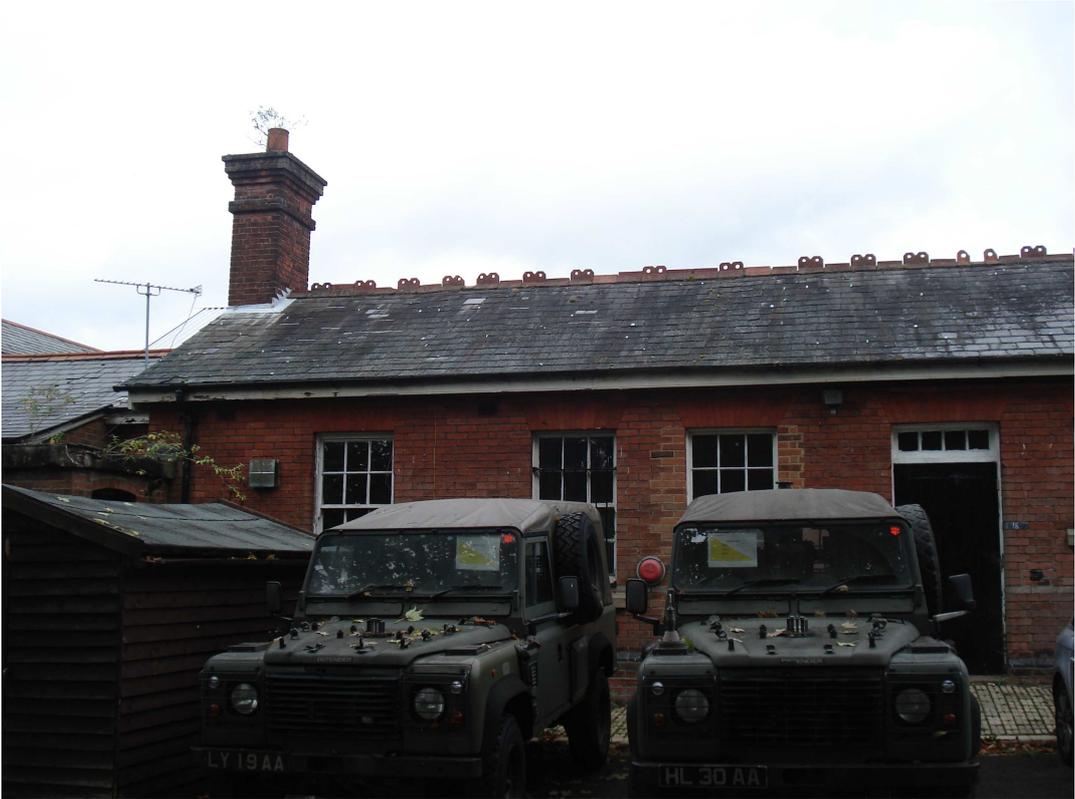
Outbuildings to far north-east of site: Long range of possibly small offices or accommodation. Single storey. Red brick with pitched natural slate roof with gables. Decorative red clay ridge tiles. Two small brick chimneys. Timber boarded doors with rectangular fanlights with glazing bars. Windows are vertical sliding sashes, mostly six-over-six. Attractive buff clay paviour apron to west side of building.

Outbuilding (probably formerly accommodation), part of a group of outbuildings to north and north-west of Fitzwygram House, Gallwey Road, Aldershot – south-west elevation

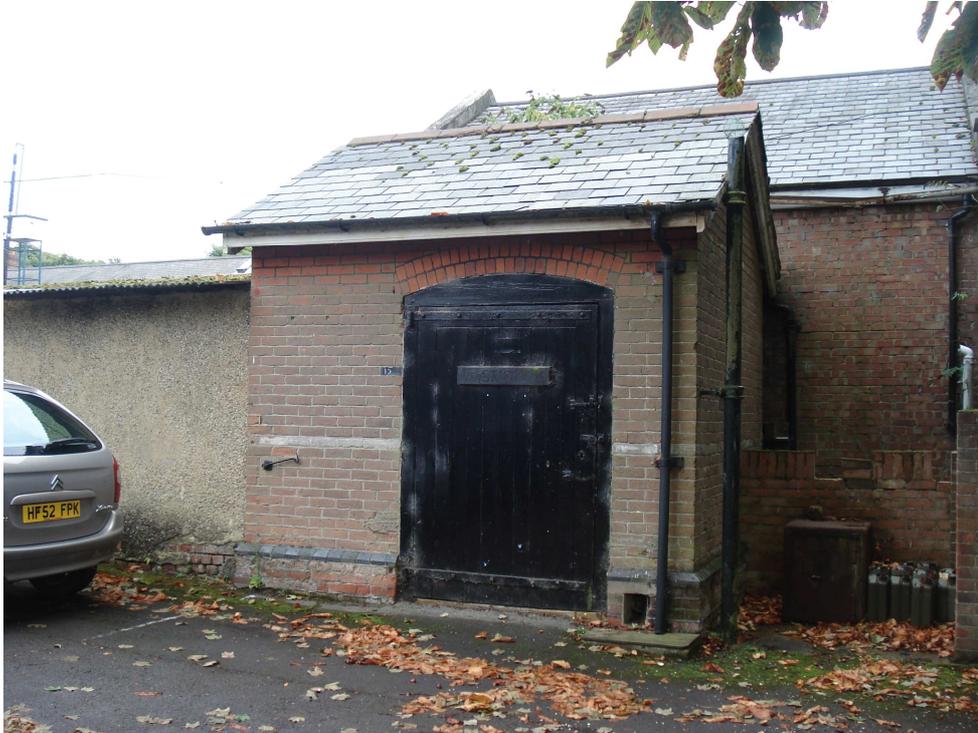
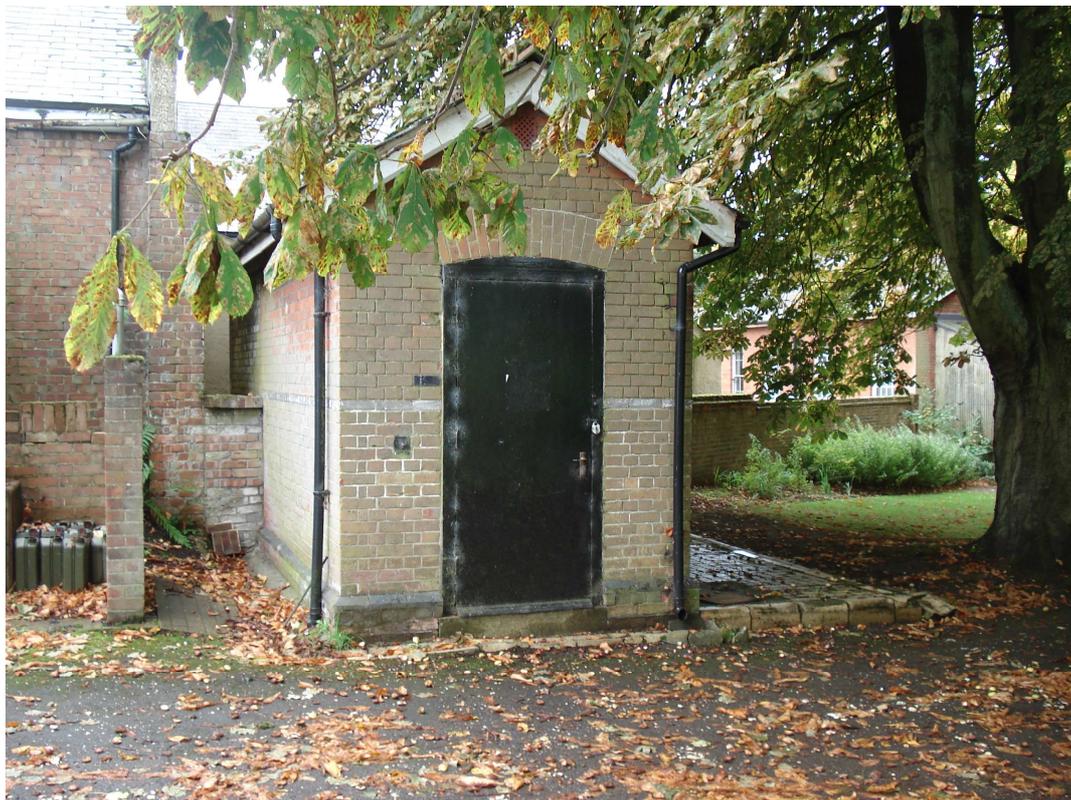
Further outbuildings (possibly dressing or disinfecting sheds): both simple almost square plan single storey buildings. Red brick (English and stretcher bond) with natural slate roof. Timber boarded doors with cambered arches to openings. Stone band above chamfered Staffordshire blue brick plinth.

Outbuilding (possibly dressing or disinfecting shed), part of a group of outbuildings to north and north-west of Fitzwygram House, Gallwey Road, Aldershot
