## Heritage Asset Survey

Heritage Asset Survey													
Building Name:	Building Reference Number:												
Statue Of Christ Calming The Storm	LL5063												
Building Address:	Listing Grade:												
Manor Park Church Hill Aldershot Hampshire	<table style="width: 100%; border: none;"> <tr> <td style="width: 25%;">I</td> <td style="width: 25%; text-align: center;"><input type="checkbox"/></td> <td style="width: 25%;">II</td> <td style="width: 25%; text-align: center;"><input type="checkbox"/></td> </tr> <tr> <td>II*</td> <td style="text-align: center;"><input type="checkbox"/></td> <td>Locally Listed</td> <td style="text-align: center;"><input type="checkbox"/></td> </tr> <tr> <td></td> <td></td> <td></td> <td style="text-align: center;">+</td> </tr> </table>	I	<input type="checkbox"/>	II	<input type="checkbox"/>	II*	<input type="checkbox"/>	Locally Listed	<input type="checkbox"/>				+
I	<input type="checkbox"/>	II	<input type="checkbox"/>

<b>PHOTOGRAPHIC LOG - LL5063</b>	<b>Client</b>	RUSHMOOR BOROUGH COUNCIL	<b>Title</b>	LOCAL LIST PHOTOGRAPHIC LOG
	<b>Date</b>	04/08/10	<b>Signed</b>	<i>SBHale</i>

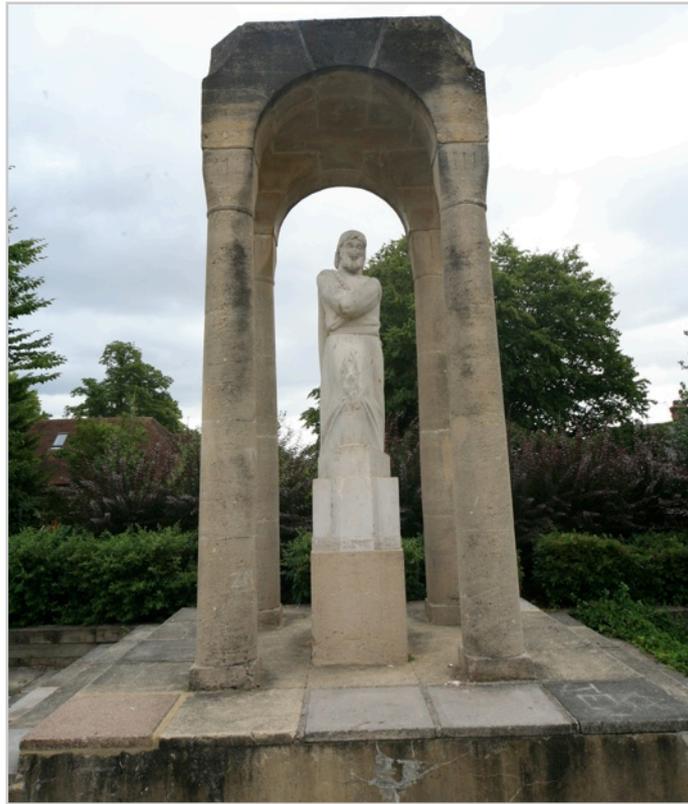
**Memorial Statue**  
Manor Park, Aldershot

Nose broken off figure should be replaced. Sulphur deposits on stone. Graffiti in places. Concrete plinth has cracking but is stable. Concrete paving stones are a mixture of old and new, replacements not of the same specification and are poorly laid with wide joints and different coloured mortar.
