Heritage Asset Survey						
Building Name:			Building Reference Number:			
St Josephs Rectory			LL5075			
Building Address:			Listing Grade:			
Queens Road						
Aldershot			I II			
Hampshire				l		
GU11 3JB				_		
			II* Locally	y Listed	+	
				l		
Listing Criteria Met	B, H					
(see Box B of the						
SPD)						
Date Locally Listed:	26th March 2012		Conservation Area:	Yes: +	No:	
·			ouis Hall. Red			
			e to roadside 2			
		_	o double height	_	_

PHOTOGRAPHIC LOG - LL5075

Client	RUSHMOOR BOROUGH COUNCIL	Title	LOCAL LIST PHOTOGRAPHIC LOG
Date	04/08/10	Signed	3BHale

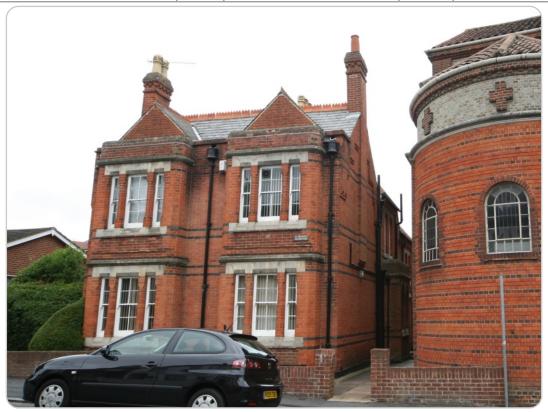
St Joseph's Rectory (S elevation) Queen's Road, Aldershot

Ownership Type (please tick the appropriate box below):					
Private		Local Authority			
Religious / Charity	+	Stat Undertakers			
Company		Crown			
Photographs					
Date Taken: 04/08/10					
Sulphur staining on ashlar which shows some signs of erosion.
